# Radiology of acute hip and femoral injuries

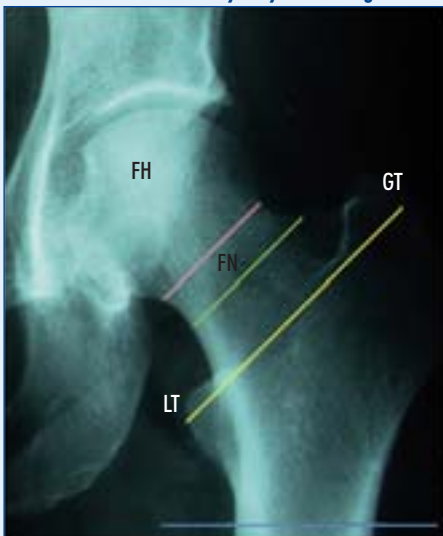
**Figure 2. Anatomy of femur with medial displacement into acetabulum. FH= femoral head; FN= femoral neck with good trabecular pattern; GT= greater trochanter; LT= lesser trochanter. Pink = subcapital fracture; green = transcervical fracture; yellow = intertrochanteric fracture; blue = subtrochanteric fracture. Pink and green are intracapsular and yellow and blue are extracapsular. The difference is in the way they are managed.**

Radiological classification of fractures of the neck of femur (Figure 2) is: subcapital, transcervical, intertrochanteric or subtrochanteric. A femoral neck fracture is called subcapital (Figure 3) when it is at the junction of the head and neck while intertrochanteric fractures (Figure 4) are fractures extending between the greater and lesser trochanters. The transcervical fractures (Figure 5) are fractures through the neck of the femur, in between the sites of the aforementioned fractures. Subtrochanteric fractures are fractures of the proximal femur distal to the lesser trochanter (Figure 6).

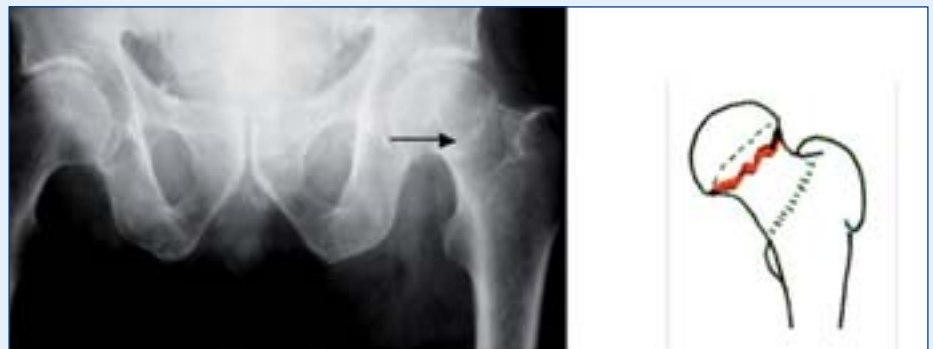
**Figure 3. Left subcapital fracture, seen just below the head of the left femur.**

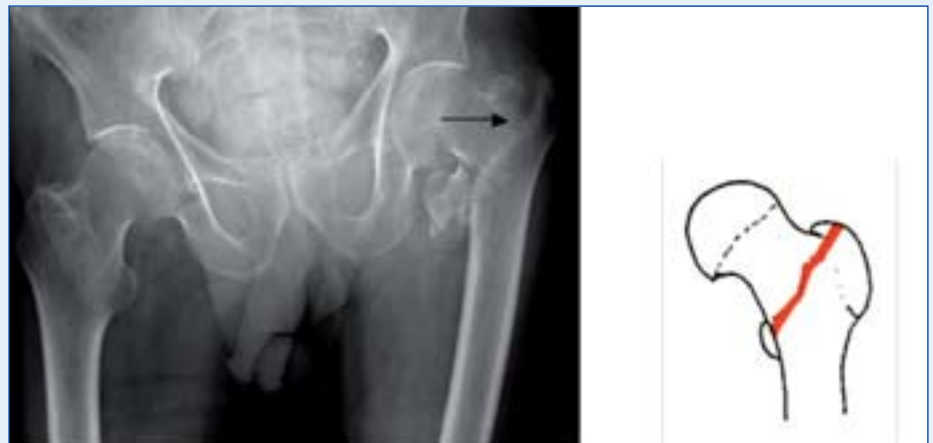
**Figure 4. Left intertrochanteric fracture. The smooth outline of the femoral neck is lost. Fracture fragments arising from the lesser and greater trochanters are seen.**

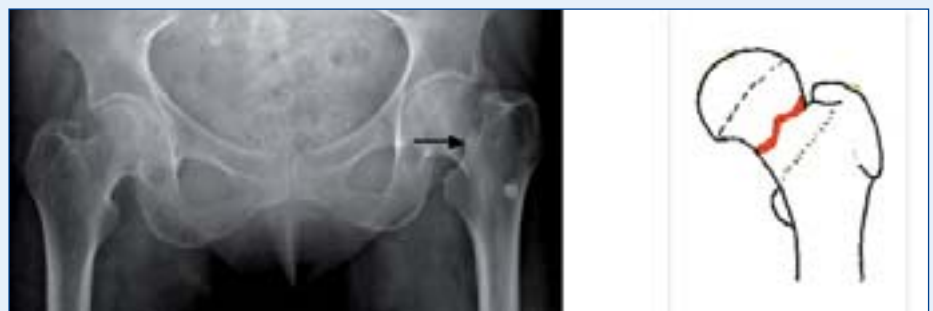
**Figure 5. Transcervical fracture in left femur. Note the loss of symmetry between both femurs and the shortened neck of femur on left.**

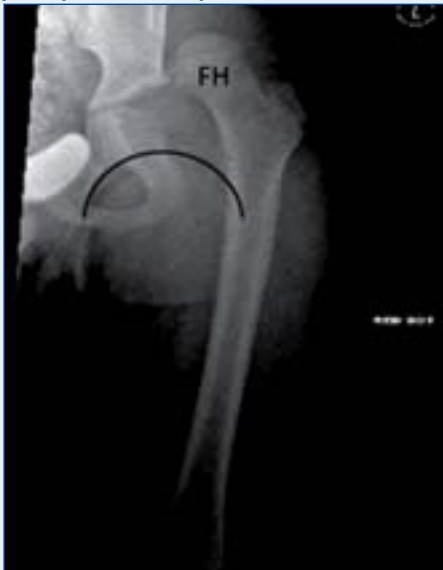
**Figure 7. Posterior dislocation. Femoral head (FH) is placed posterior and superior to the acetabulum.**

In a posterior dislocation, the femoral head is situated superior and lateral to the acetabulum on an anteroposterior pelvic radiograph (Figure 7). This is the most common type of hip dislocation in adults (80–90% of cases). The mechanism of injury is generally the result of a road accident when someone seated in a vehicle is propelled forward, with the knee striking the dashboard. This is often associated with fractures of the acetabulum and occasionally fractures of the femoral head.

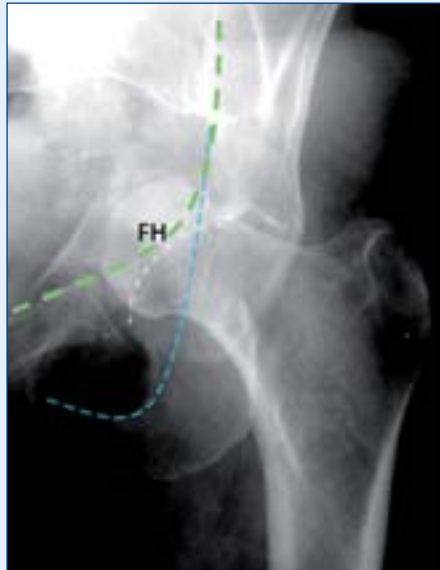
**Figure 8. Femoral head (FH) is situated medial to the acetabulum (white dotted line) and medial to the ilioischial line (blue) and iliopectineal line (green) consistent with a central dislocation of the femoral head.**

The femoral head lies medial to a fractured acetabulum (Figure 8). This is caused by a

lateral force against an adducted femur. The causes of these dislocations are the same as posterior dislocations are the same. Note that the femoral head is seen medial of both the iliopectineal and ilioischial lines. **BJHM**
