Removal of a titanium alloy ring

Case Report

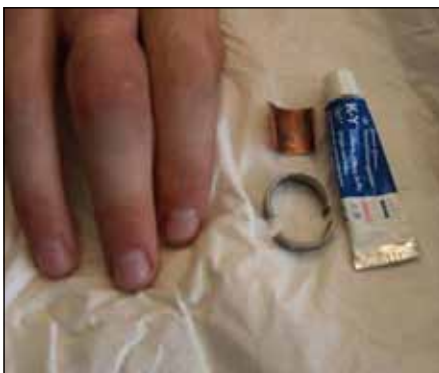
Figure 1. Equipment used and the cut ring.

The solution was found in the hospital works department. A small powered hand saw with a diamond-headed blade was obtained. With lubrication, a small, cut piece of copper piping was passed between the ring and the finger for protection. The ring was cut in one place, rotated and cut on the opposite side (Figure 1). A jet of water was sprayed on the saw head to reduce thermal injury.

The diamond-headed blade was initially approximately 5 cm wide but on completion of cutting was only 2 cm wide. The patient sustained no secondary injury and made a satisfactory recovery.
