Radiology of acute foot injuries

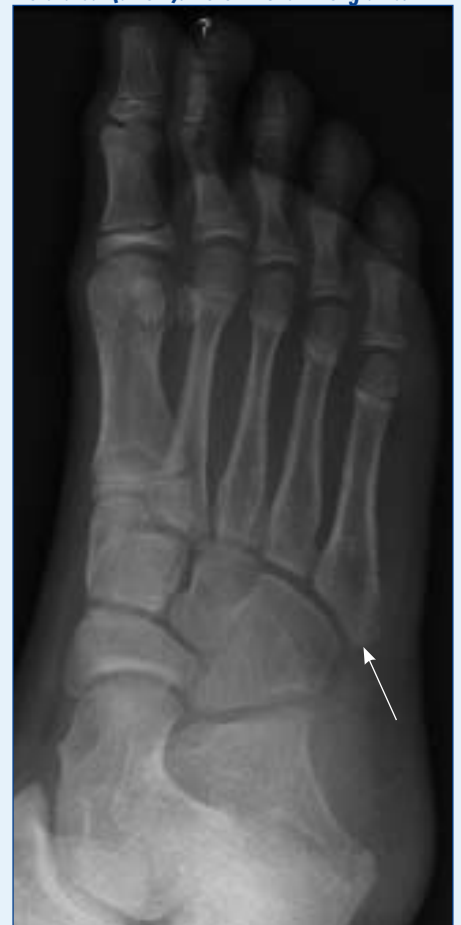
Figure 1. Normal anatomy of the foot, showing the normal apophysis of the base of the fifth metatarsal (arrow). Note it runs in long axis.

The metatarsals and phalanges are similar to the metacarpals and phalanges in the hands. The only unique issue to be aware of in the forefoot is that the normal apophysis of the base of the fifth metatarsal runs in long axis (Figure 1), parallel to the metatarsal, and should not be mistaken for a fracture line. A fracture is commonly seen perpendicular to the metatarsal.

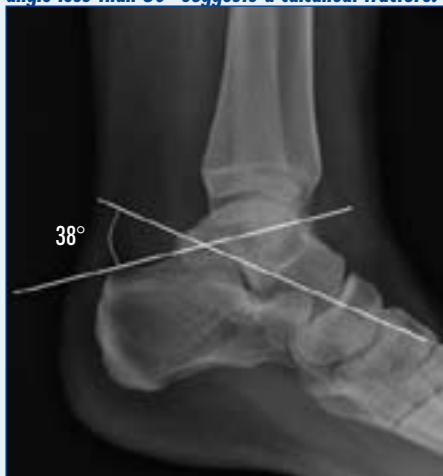
Figure 3. Bohler's angle is normally 30–40°. An angle less than 30° suggests a calcaneal fracture.

Standard calcaneal views include the more useful lateral view, and an axial view. The lateral view can be used to assess Bohler's angle, where a line is drawn from the supero-posterior aspect of the calcaneus to its highest midpoint, and from this point to its highest point

anteriorly. This should normally measure between 30° and 40° (Figure 3).

A calcaneal fracture may only be evident if there is a decrease in Bohler's angle to below 30°. However, a normal Bohler's angle does not exclude a fracture.

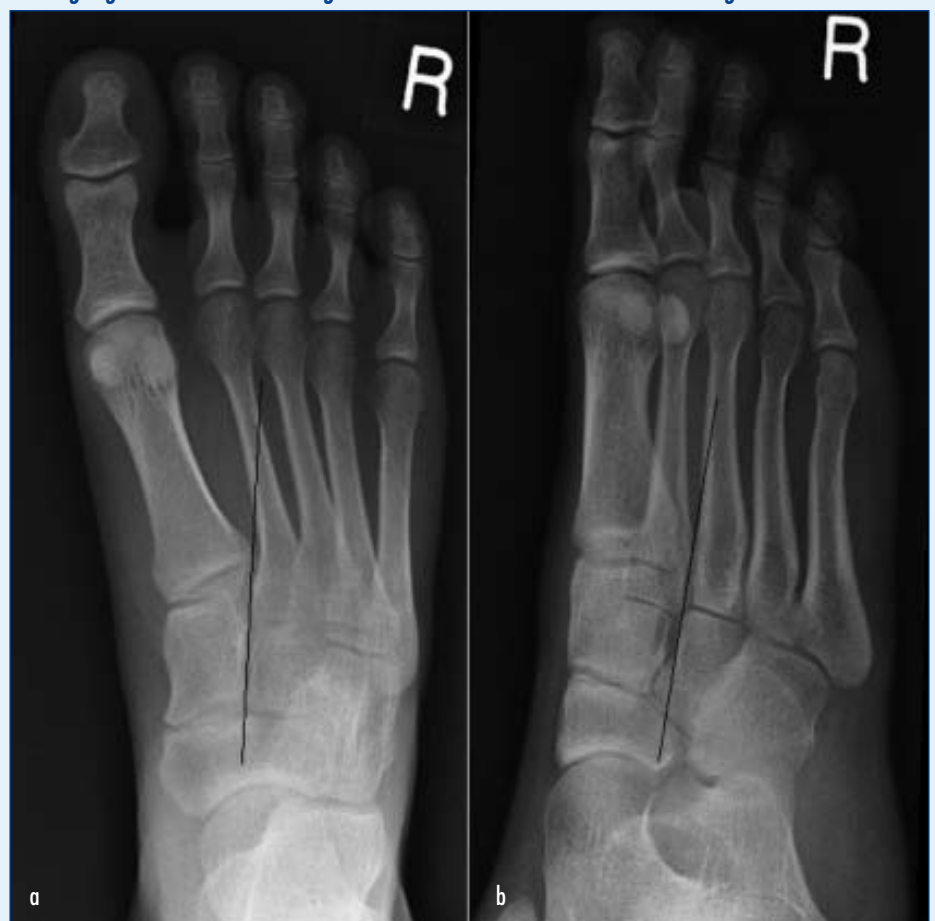
Figure 4. a. Anteroposterior radiograph of the normal foot, showing alignment of the medial margin of the second metatarsal with the medial margin of the middle cuneiform. b. Oblique radiograph of the foot, showing alignment of the medial margin of the third metatarsal with the medial margin of the lateral

The dorsi-palmar projection shows the medial margin of the second metatarsal

align with the medial margin of the middle cuneiform (Figure 4).

The oblique projection shows the medial margin of the third metatarsal align with the medial margin of the lateral cuneiform.

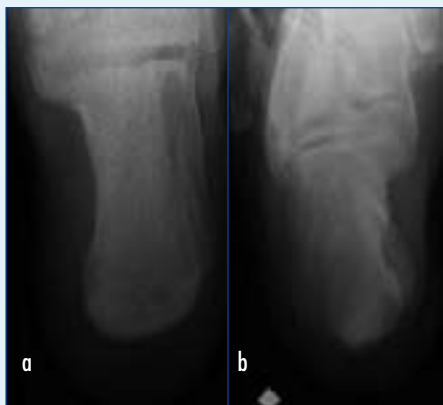
Figure 5. a. A normal calcaneus. b. A calcaneal fracture with cortical irregularity and loss of the regular trabecular pattern.

The calcaneus normally has a well-defined trabecular pattern. Subtle fractures can distort this pattern (Figure 5). A small sclerotic line may be the only feature of a calcaneal fracture. Additionally, a reduced Bohler's angle can be the only finding to suggest a fracture (Figure 6).

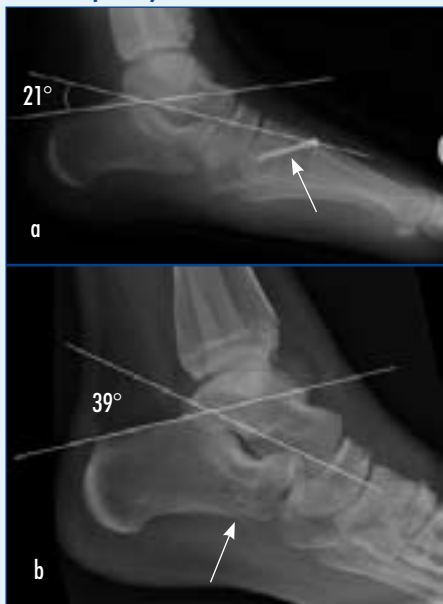
Figure 6. a. A calcaneal fracture with Bohler's angle of less than 30°. This is highly suggestive of a calcaneal fracture. The calcaneal cortex is also irregular. Note the fixed Lisfranc injury (arrow). b. Note not all calcaneal fractures demonstrate a decreased Bohler's angle. The fracture is clearly identified (arrow).

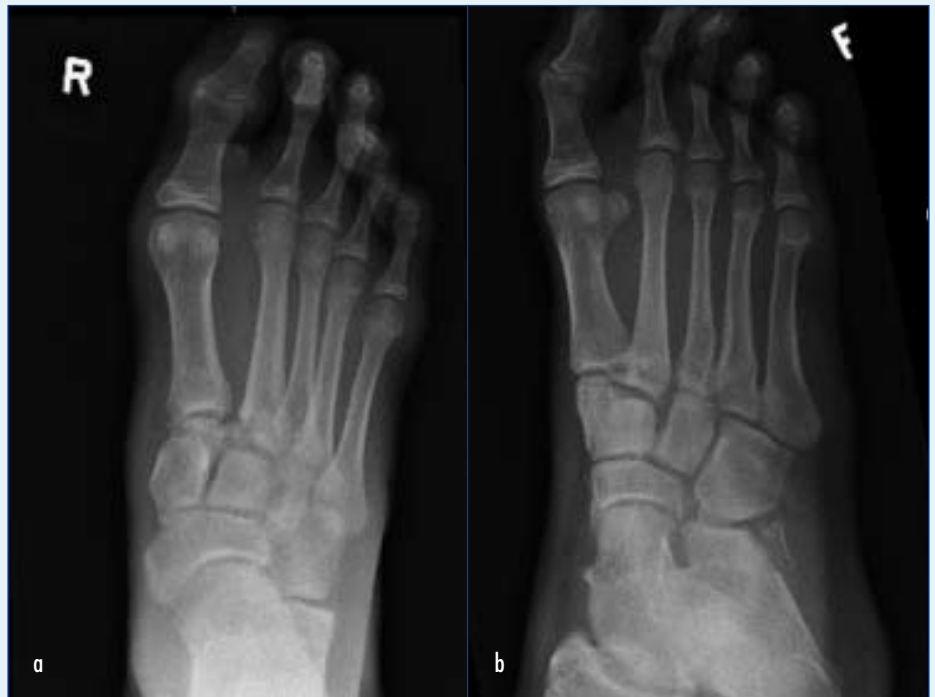
Figure 7. Lisfranc injury. a. The anteroposterior view best shows the malalignment, indicating ligamentous injury. The fracture of the base of the second metatarsal is seen in both views, and the associated fracture of the calcaneus on the oblique view (b).

If a bony fragment is detached from the base of one of the four medial metatarsals, a Lisfranc injury should be suspected

(Figure 7). This injury may, however, be clearly visible as a result of a lateral shift of the metatarsals on the cuneiforms.

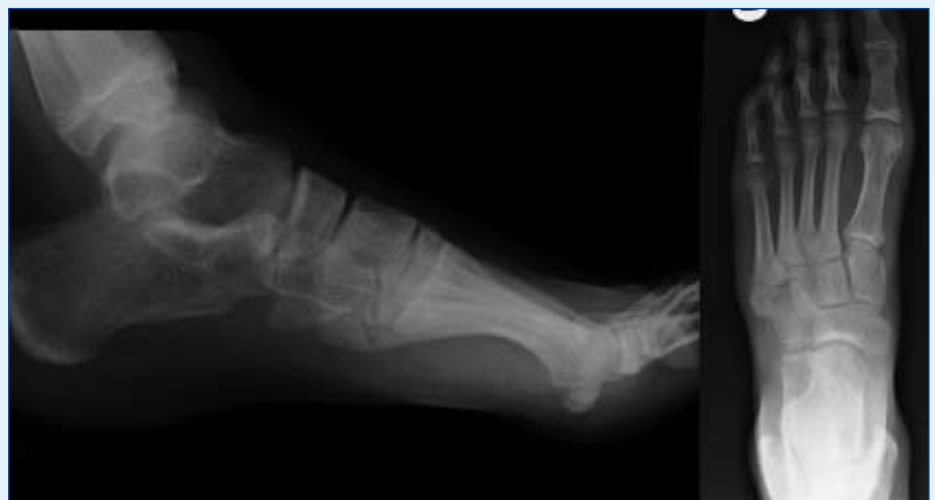
Figure 8. A fracture of the base of the fifth metatarsal base is seen on the lateral and anteroposterior radiographs. Compare with the normal apophysis in Figure 1.

Fractures of any of the bones may be easily identified, as with any other bone. A fracture of a metatarsal (Figures 8 and 9) will commonly demonstrate periosteal reaction resulting from osteogenesis. If this is not evident, but suspicion remains, a repeat radiograph after a few days, isotope bone scan or magnetic resonance

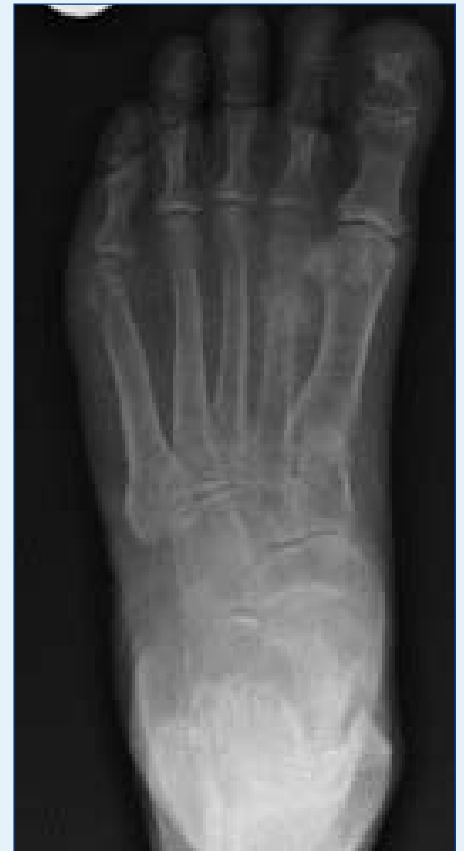
Figure 9. A stress fracture of the second metatarsal with periosteal reaction and callous formation.
