## Extreme tortuosity of the iliac artery

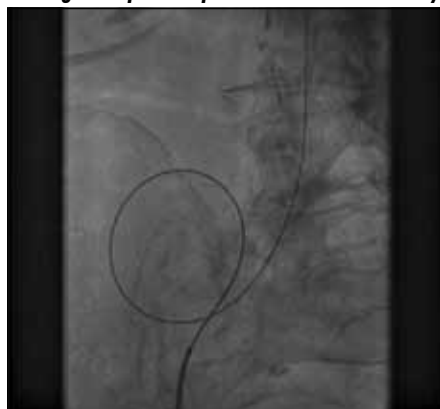
**Figure 1. Fluoroscopy showed guidance wire forming a complete loop in the common iliac artery.**

A 76-year-old woman underwent coronary catheterization via the right femoral artery. Arterial puncture was clean and the sheath was inserted over the wire but difficulty advancing the guide wire necessitated a change to a hydrophilic wire. Under fluoroscopy the wire formed a complete loop in the common iliac artery (*Figure 1*). The left femoral approach was not attempted as a similar problem as anticipated. Contrast computed tomography of the pelvic vessels and aorta showed an unusually tortuous right iliac artery with complete loop formation (*Figure 2*). The left iliac artery was also tortuous. The patient underwent radial coronary angiography.

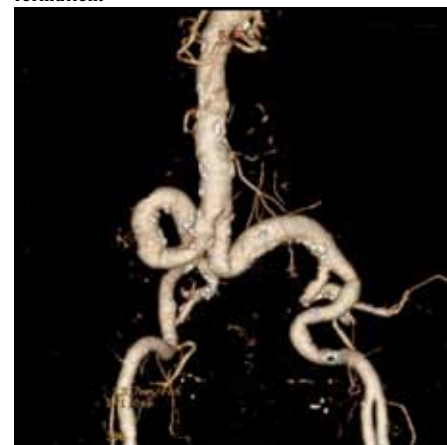
**Figure 2. Contrast computed tomography of pelvic vessels and aorta showed an unusually tortuous right common iliac artery with a complete loop formation.**

Early identification of tortuous iliac arteries is important, as they can lead to kinking and knotting of catheters causing spasm and perforation. Besides complicating vascular procedures, they increase fluoroscopic time and radiation dose, and have been associated with endovascular fibrosis (Lim et al, 2009). Computed tomography is useful in
